SUNKEN DRY DOCK REFLOATED

12/2010

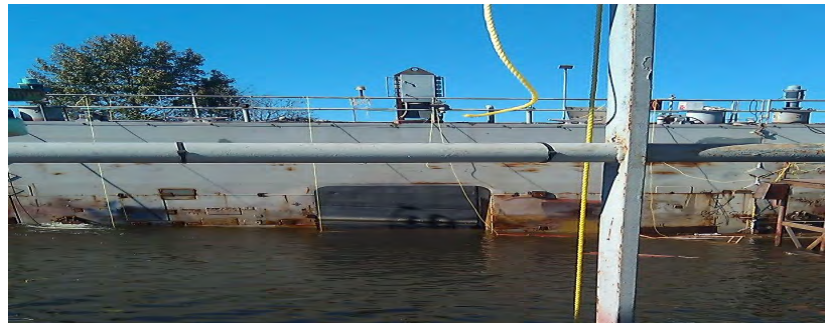
LOGAN DIVING & SALVAGE OF JACKSONVILLE, FLORIDA RECENTLY PROVIDED UNSCHEDULED DIVING SERVICES AND EQUIPMENT TO RAISE A SUNKEN DRY DOCK IN THE ST. JOHNS RIVER.

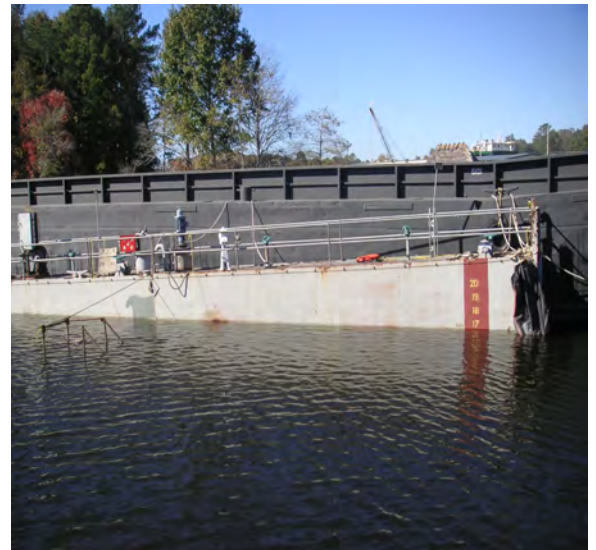
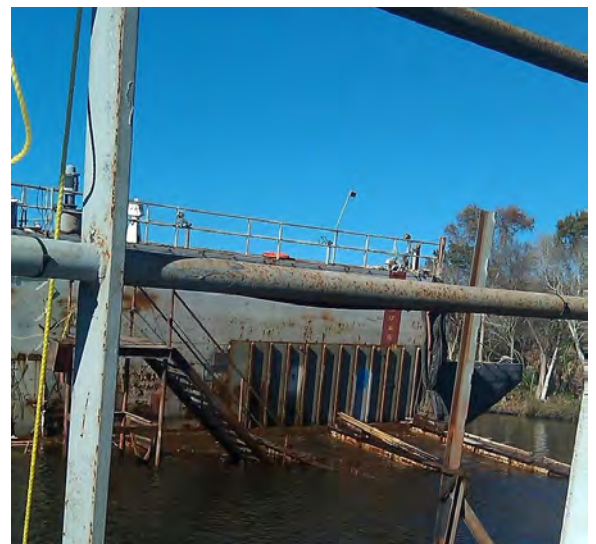
OVER 21 SALVAGE PATCHES WERE INSTALLED ON THE 3 MODULE, 6 COMPARTMENT DRY DOCK IN ONE DAY ON SITE. DEWATERING WAS EXECUTED IN UNISON AND AT THE DIRECTION OF THE LDS SALVAGE MASTER. ADDITIONAL HOLES AND FAILURES WERE EVIDENCED ONCE DEWATERING BEGAN. ADDITIONAL SALVAGE PATCHES WERE FABRICATED ON SITE AND INSTALLED AS DEWATERING CONTINUED. THE VESSEL WAS RIGHTED AND RAISED AS EVENLY AS POSSIBLE TO PREVENT ANY ADDITIONAL STRUCTURAL DAMAGE.

WORKING WITH THE OWNER'S CREWS, THE CASUALTY WAS SURVEYED, REPAIRED AND REFLOATED IN 3 DAYS OF UNSCHEDULED FULL TIME COMMERCIAL DIVING SALVAGE OPERATIONS.
