## Dramatic Underwater Repair in Indian River Keeps Florida City Gas Customers Online

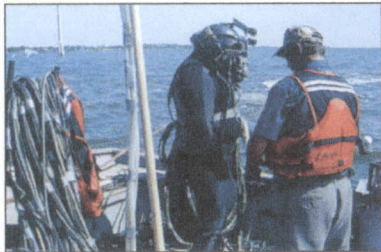
Logan Divers handled the underwater duties.

Using vacuums to suck up the sandy sediment, divers spent two days excavating a 30-foot-long by 6-foot-deep by 2-foot-wide hole around the leaking pipe. The sediments were "jetted" on to the side underwater to be replaced later. Three divers rotated in shifts of four hours underwater throughout the five days of the project.

The pressure in the 60-pound line was lowered and equalized at 15 pounds, which was maintained so water would not enter the line. To install the **Syntho-Glass**, the divers mixed a two-part Kevlar-reinforced epoxy and applied it to the pipe in preparation for winding the woven **Syntho-Glass** around the pipe. Just 30 minutes after they began the process, winds on the surface kicked up to 30 mph, stirring up silt below and decreasing visibility.

But the AGL Resources team persevered. The epoxy application took two hours, then the divers began to wrap. Over two days, the divers applied a total of 28 rolls of 4-, 6- and 8-inch-wide **Syntho-Glass** to build a "composite sleeve" around the leaking pipe. The AGL Resources team monitored the 15-pound pressure in the pipe overnight, until the process was complete.
